Detecting Cracks in a Rail Axle Center Using Eddy Current Testing

A customer needed a conventional eddy current solution to detect cracks in two areas of a rail axle center: the counter and the center bores. The goal was to create a solution to minimize operator intervention with both equipment and instrument settings.

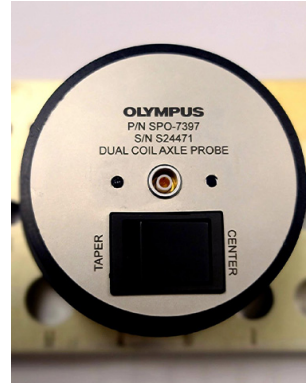
- NORTEC™ 600 eddy current flaw detector
- SPO-7397 custom dual coil axle center probe—Q6100015:
 - The probe contains one bridge differential coil to test the length of the tapered section and one small bridge differential coil to test the bottom bore of the axle center

Probe setup to inspect defects in a rail axle center

The test setup involved placing the probe in the axle center, using the switch to set the area of inspection (taper or center), nulling the coils, and rotating over the electrical discharge machined (EDM) notches provided by the customer.

To change areas of interest, the operator must simply switch the selector to change coils, input the appropriate test settings, and null the instrument.

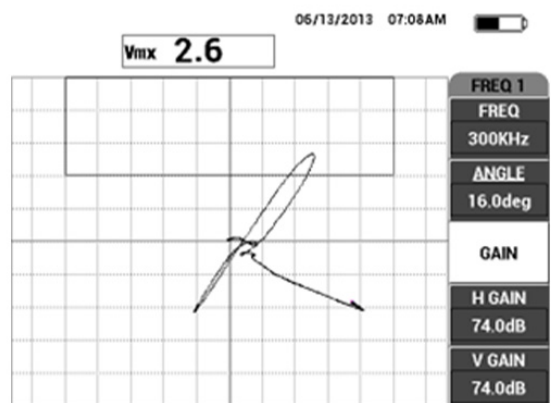
Test signal on a notch (0.381 mm or .015 in. deep) in the center bore

Both tests can be conducted at 300 kHz with minimal changes in settings. Gain adjustment and angle adjustment can be used to improve results.

As seen in the instrument screenshots, notches on the customer-supplied test/reference standard were detected with a favorable signal-to-noise ratio. The eddy current solution reduces the changeover time between area of inspection setups. This successful application may lead to further probe designs for different axle geometries and can also be implemented into an automated solution.
