## Detecting Cracks in a Rail Axle Center Using Eddy Current Testing

A customer needed a conventional eddy current solution to detect cracks in two areas of a rail axle center: the counter and the center bores. The goal was to create a solution to minimize operator intervention with both equipment and instrument settings.

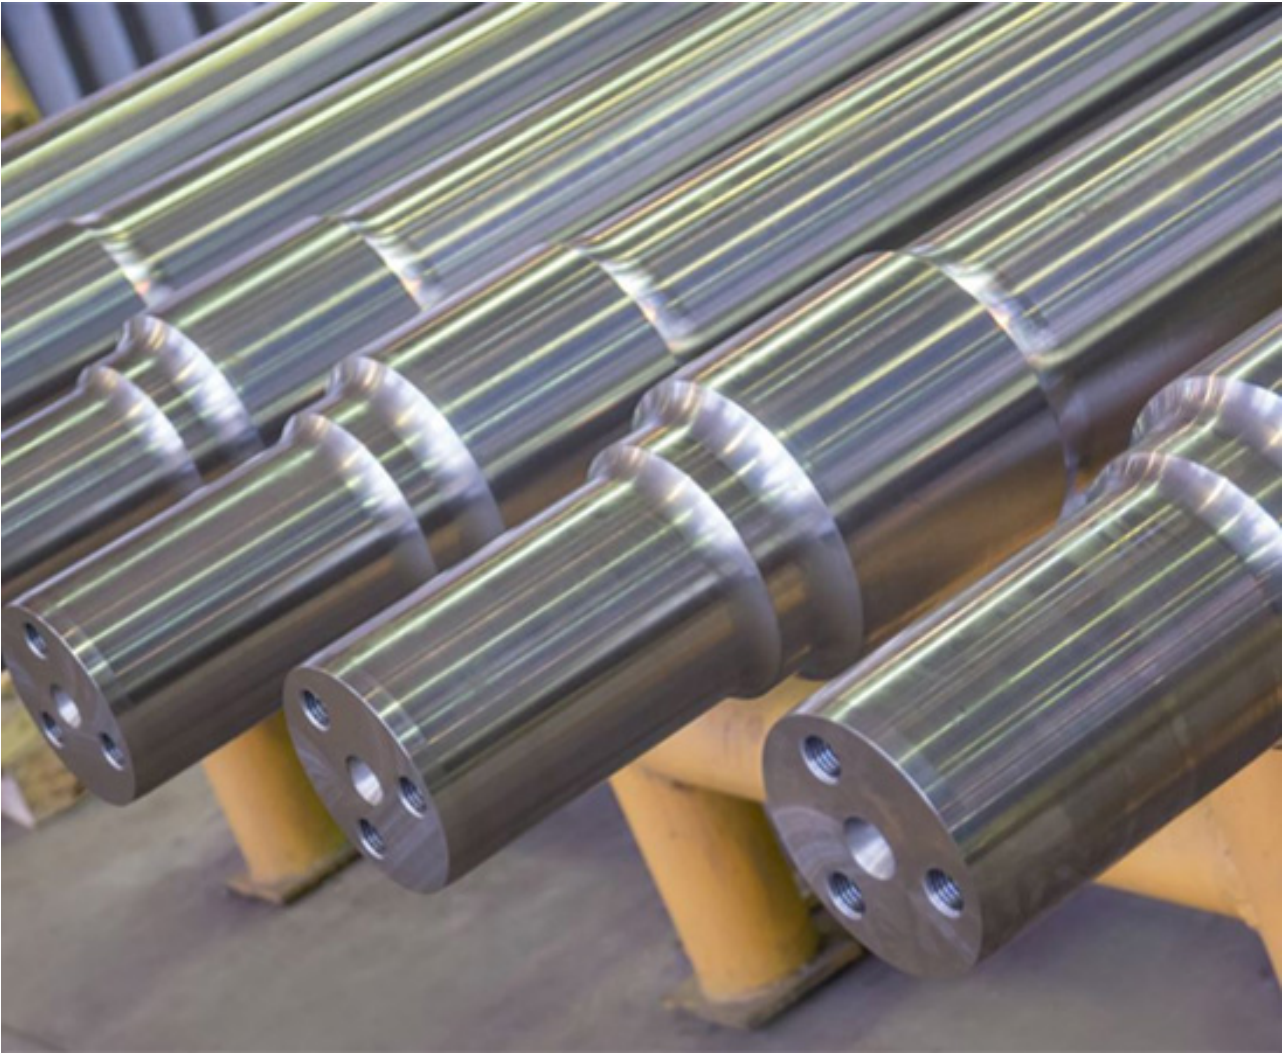
Axles

The axle shafts are forged and then machined down to meet internal specifications. The forging process can generate surface and internal defects, such as hairline subsurface cracks, inclusions, and pitting. When machined, internal deformities can increase in size and break the surface. These defects can lead to part failures.

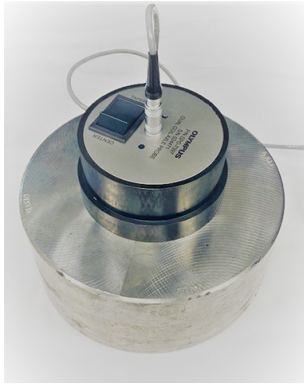
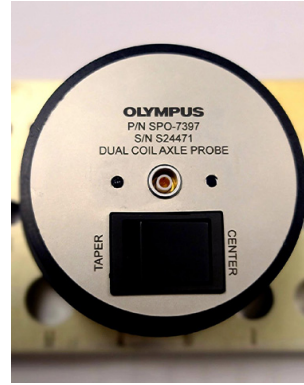
- NORTEC™ 600 eddy current flaw detector
- SPO-7397 custom dual coil axle center probe—Q6100015:
  - The probe contains one bridge differential coil to test the length of the tapered section and one small bridge differential coil to test the bottom bore of the axle center

Probe setup to inspect defects in a rail axle center

The test setup involved placing the probe in the axle center, using the switch to set the area of inspection (taper or center), nulling the coils, and rotating over the electrical discharge machined (EDM) notches provided by the customer.

To change areas of interest, the operator must simply switch the selector to change coils, input the appropriate test settings, and null the instrument.

Both tests can be conducted at 300 kHz with minimal changes in settings. Gain adjustment and angle adjustment can be used to improve results.

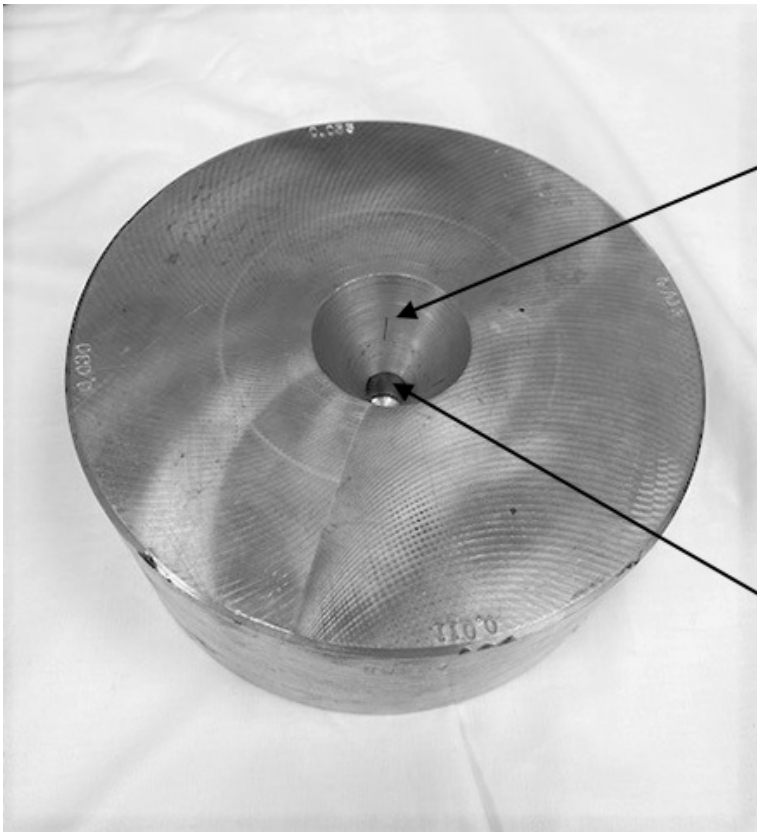
Tapered (countersink) axial flaw  
( 0.889 mm or .035 in. deep )

Center bore axial flaw  
( 0.381 mm or .015 in. deep )

The following images were taken from tests using the SPO-7397 probe on a supplied reference standard in both locations with the NORTEC 600 flaw detector.

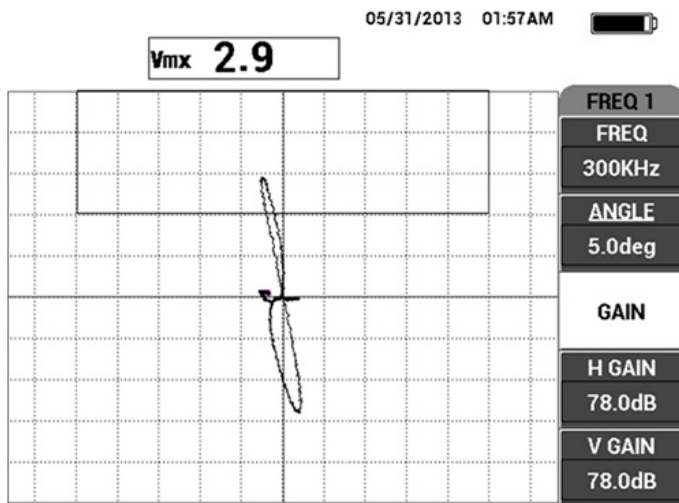
Test signal on a notch (0.889 mm or .035 in. deep) in the tapered section of the center

As seen in the instrument screenshots, notches on the customer-supplied test/reference standard were detected with a favorable signal-to-noise ratio. The eddy current solution reduces the changeover time between area of inspection setups. This successful application may lead to further probe designs for different axle geometries and can also be implemented into an automated solution.

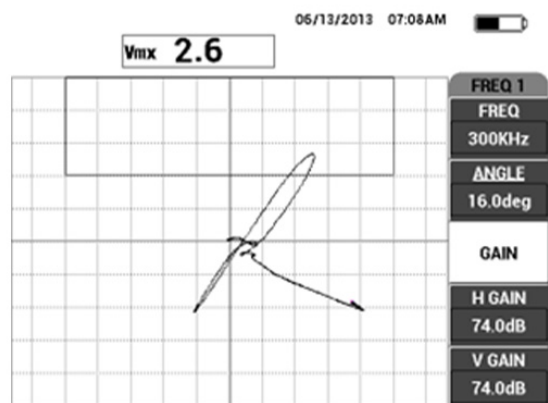
Test signal on a notch (0.381 mm or .015 in. deep) in the center bore
