Inspecting Bolts Using a Customized Phased Array Ring Probe

Bolt Inspection Application Overview

Solution Using Customized Phased Array Ring-Probe Technology

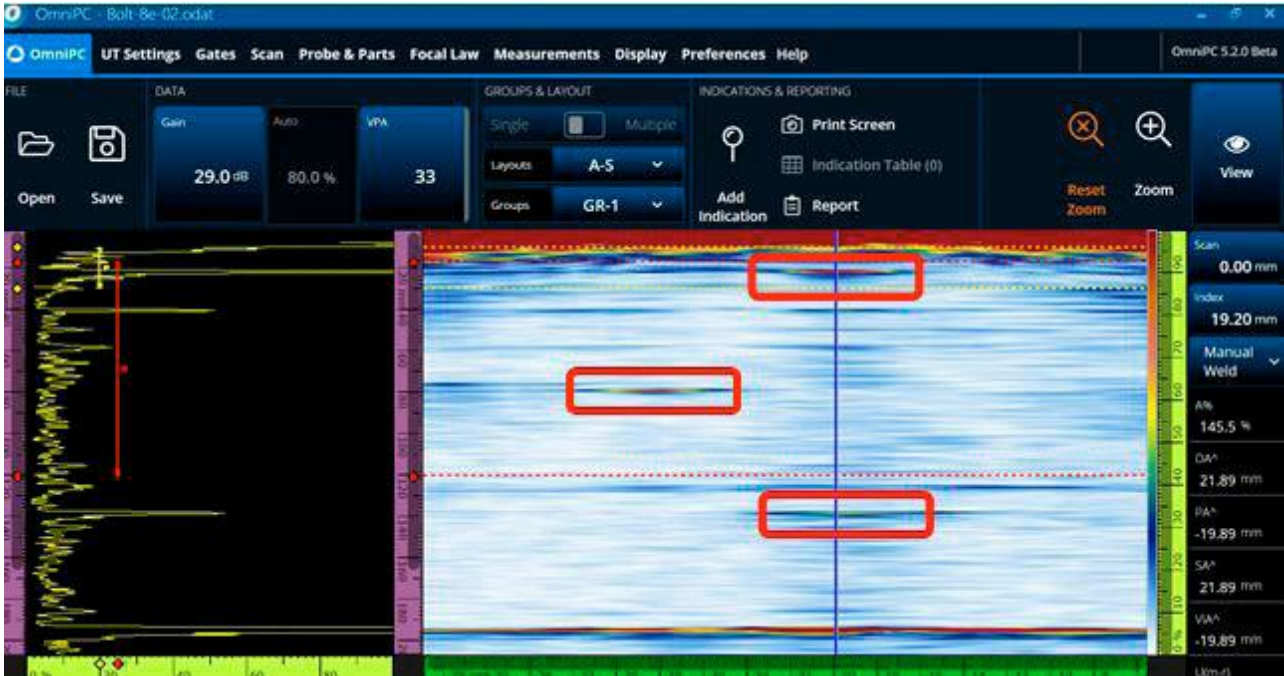
Figure 4. For the defect (groove) located 20 mm from the top surface (where the bolt head meets the screw), its detected depth was 21.89 mm.

Firing sequence: 1-8, 2-9, 3-10,...57-64

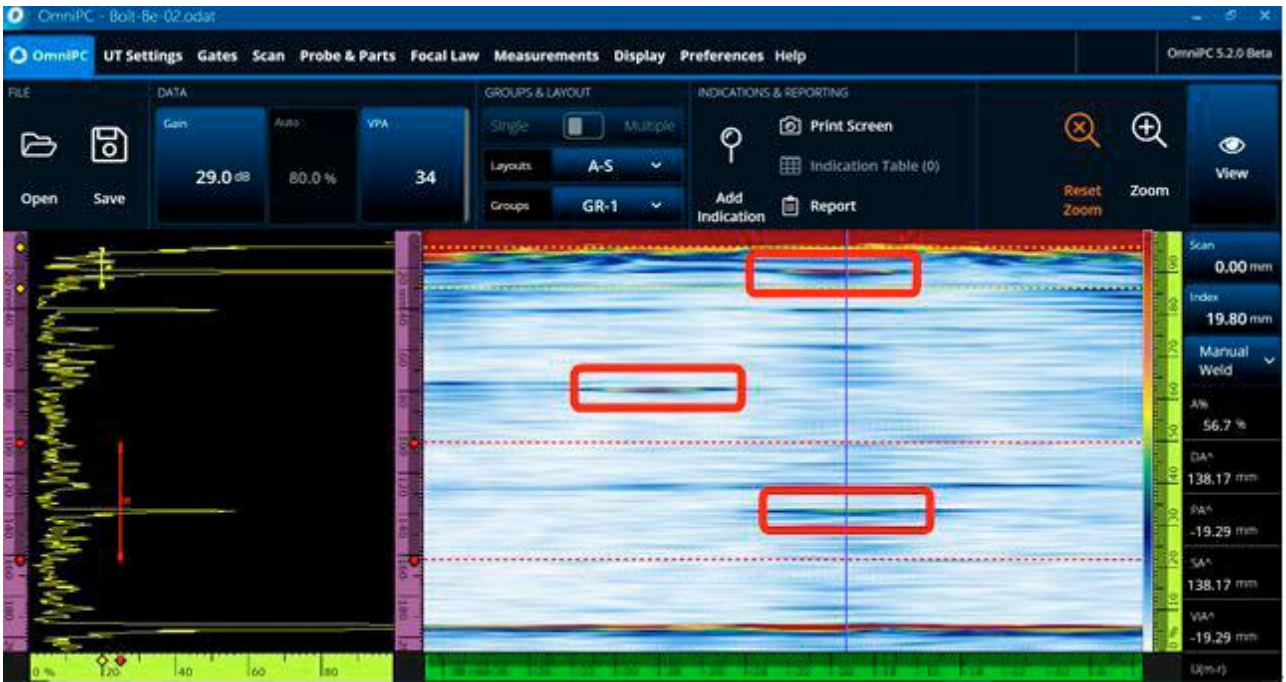
Figure 6. For the defect (groove) located 140 mm from the top surface, its detected depth was 138.17 mm.

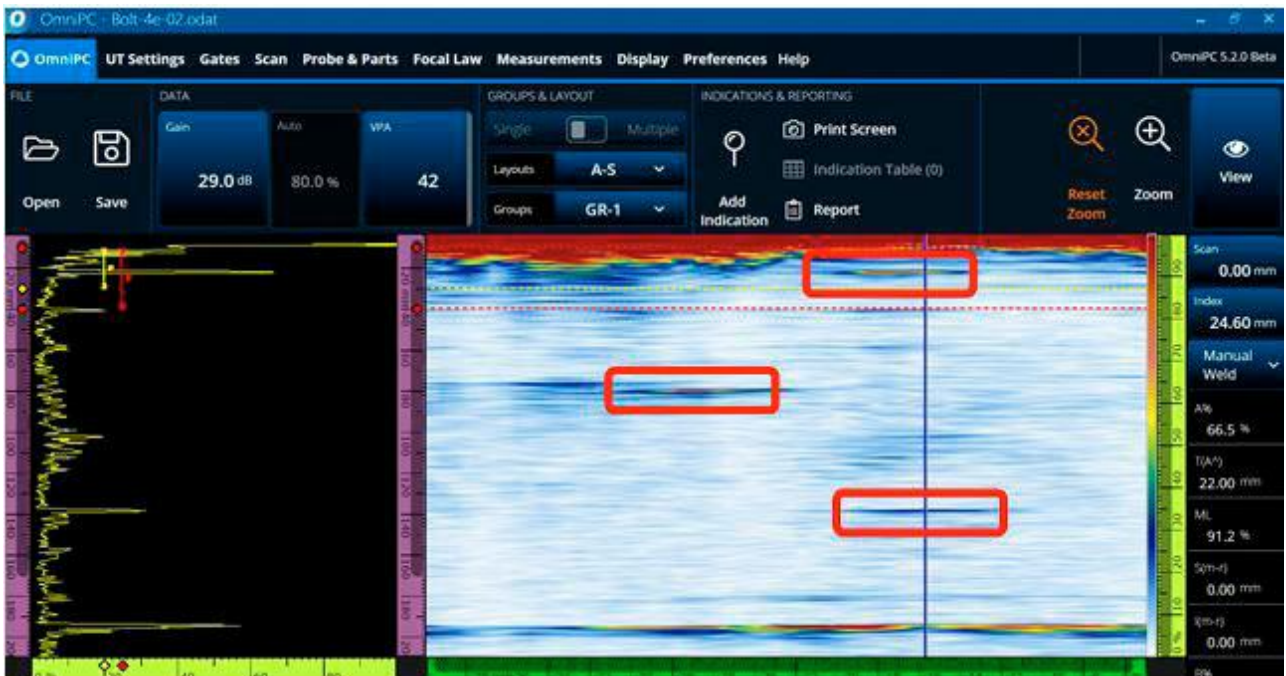
Figure 7. The signals for the shallower defects (grooves) located at 20 mm and 80 mm from the top surface are strong and the indications are clear, whereas the signal for the defect (groove) at 140 mm was weaker.

Next, we excited only 4 elements at one time, and all the other conditions remained unchanged. The test results we obtained are shown in Figure 7.

Firing sequence: 1-4, 2-5, 3-6,...61-64

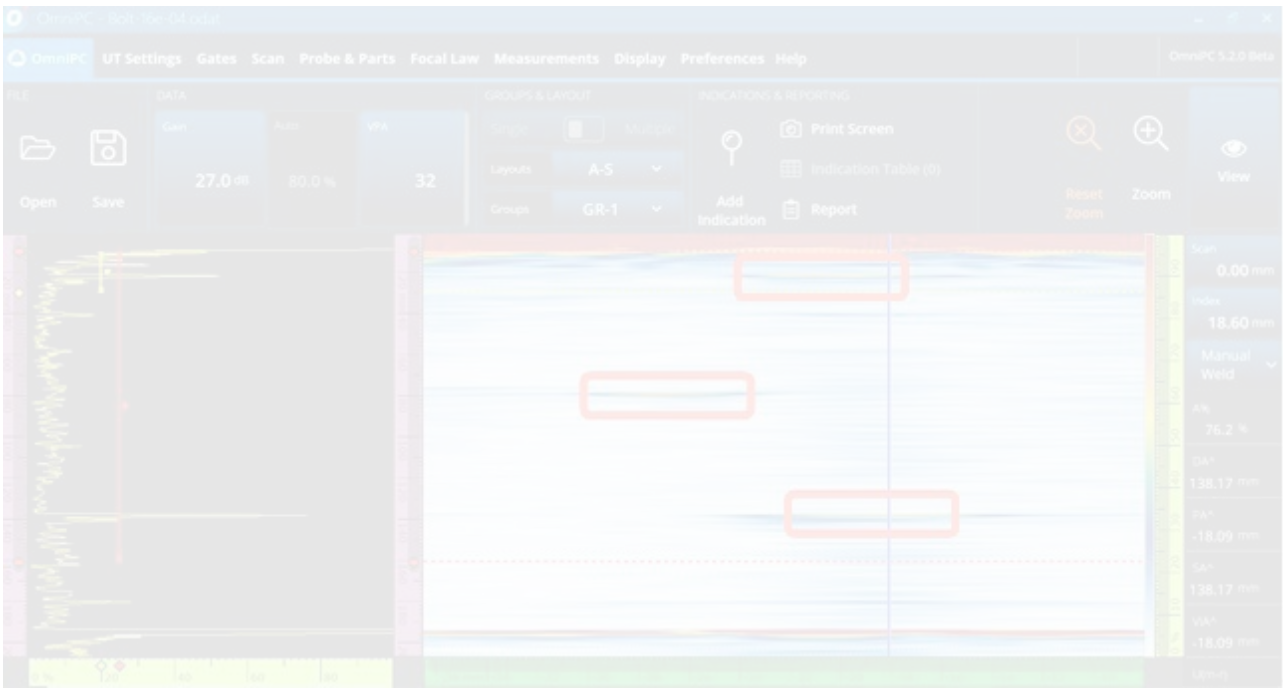
Figure 9: Test results obtained with 16 elements fired simultaneously.

Conversely, when 16 elements were excited simultaneously, the signal for the defect at 140 mm from the bolt head's top surface was displayed more clearly. However, because the 16 elements were in a circular arrangement and thus spanned a large arc, they did not focus effectively and consequently, the signal was stretched and amplified. This is the opposite of what typically happens when a linear array probe is used.

Firing sequence: 1-16, 2-17, 3-18,...49-64

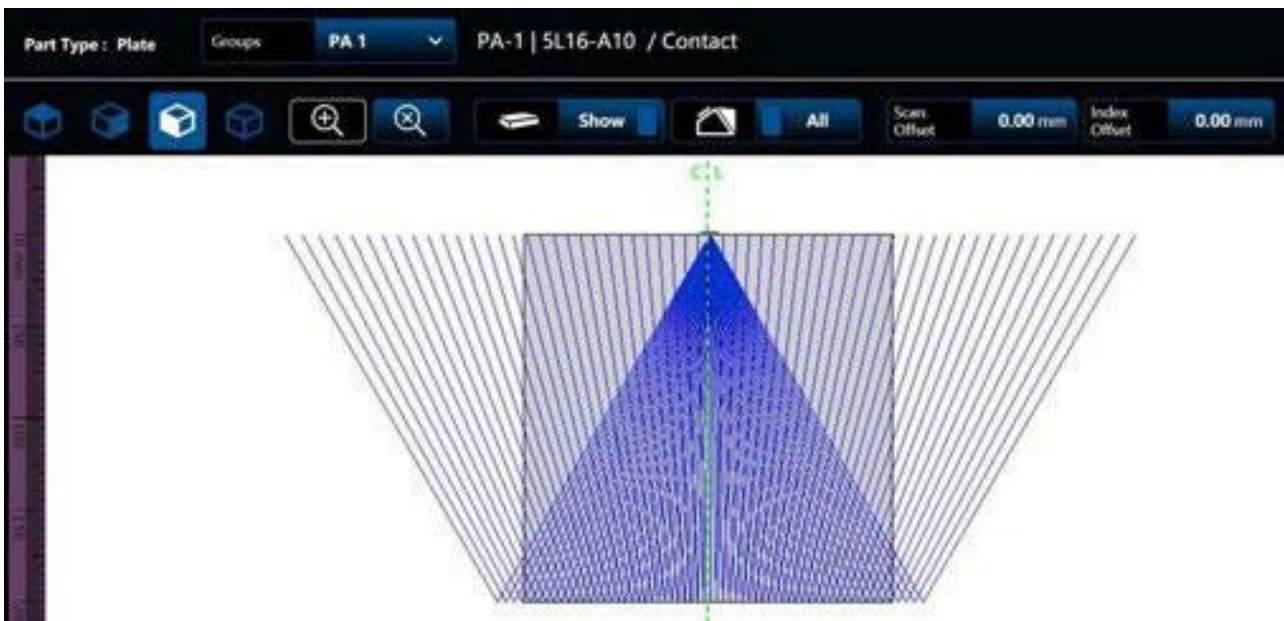
Figure 11. Beam schematic for the linear array probe on the OmniScan X3 flaw detector

This test was conducted to provide a comparison of the ring array probe's performance with that of a typical linear phased array probe (Figure 11).
