Inspecting Bolts Using a Customized Phased Array Ring Probe

Bolt Inspection Application Overview

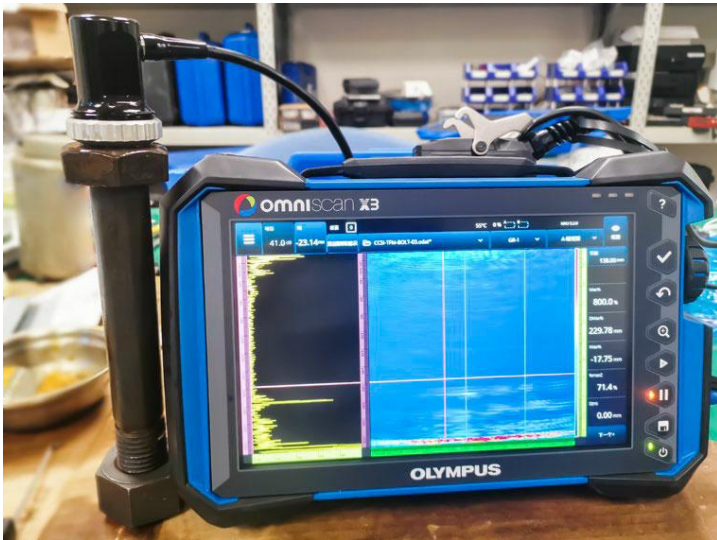
Figure 1. OmniScan X3 flaw detector connected to the ring array probe positioned on a bolt

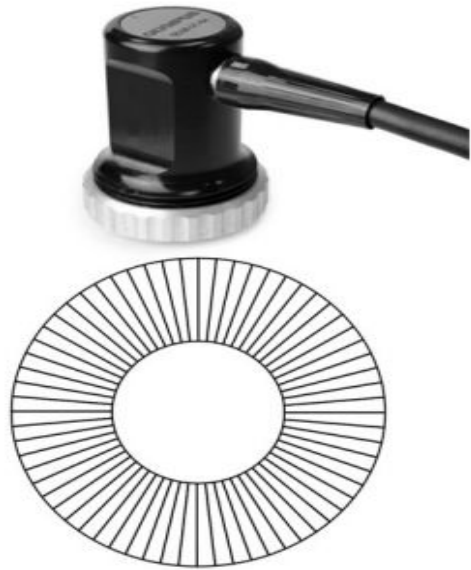
Figure 2. The custom 5D26-12-64 ring-array probe (top) and element distribution schema (bottom)

Specifications of the Customized Ring Array Probe

Outside diameter: 26 mm

Inside diameter: 12 mm

Elements: 64

Outer circumference: 81.68 mm

Inner circumference: 37.69 mm

Outer pitch: 1.276 mm

Inner pitch: 0.5889 mm

Elevation: 14 mm

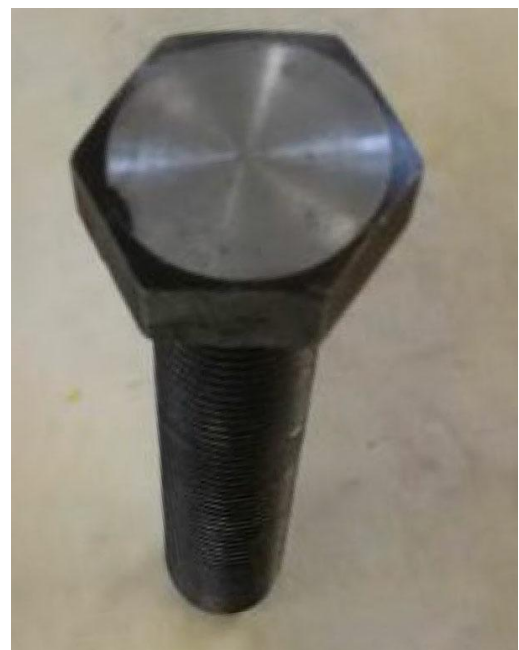
Figure 3. The bolt test block with machined flaws. This test block is a bolt with manufactured defects, namely 1 mm deep grooves located at 20 mm (where the bolt head meets the screw), 80 mm, and 140 mm from the top surface of the bolt head.

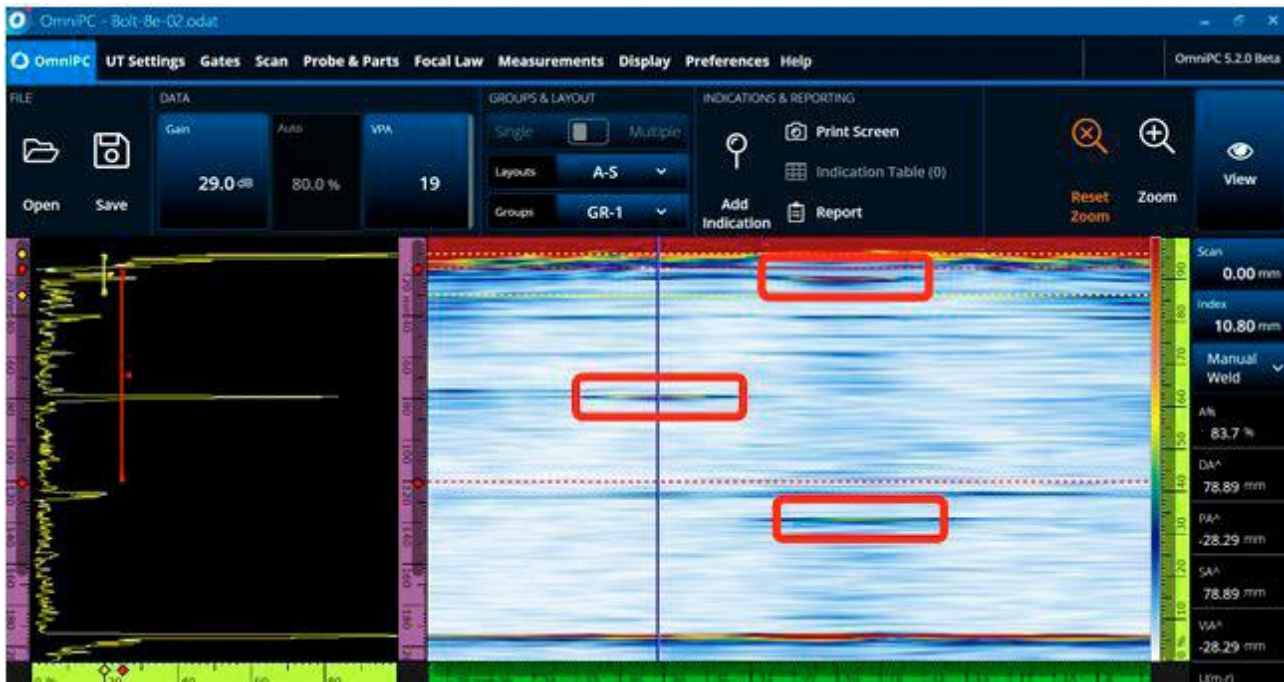
Figure 5. For the defect (groove) located 80 mm from the top surface, its detected depth was 78.89 mm.

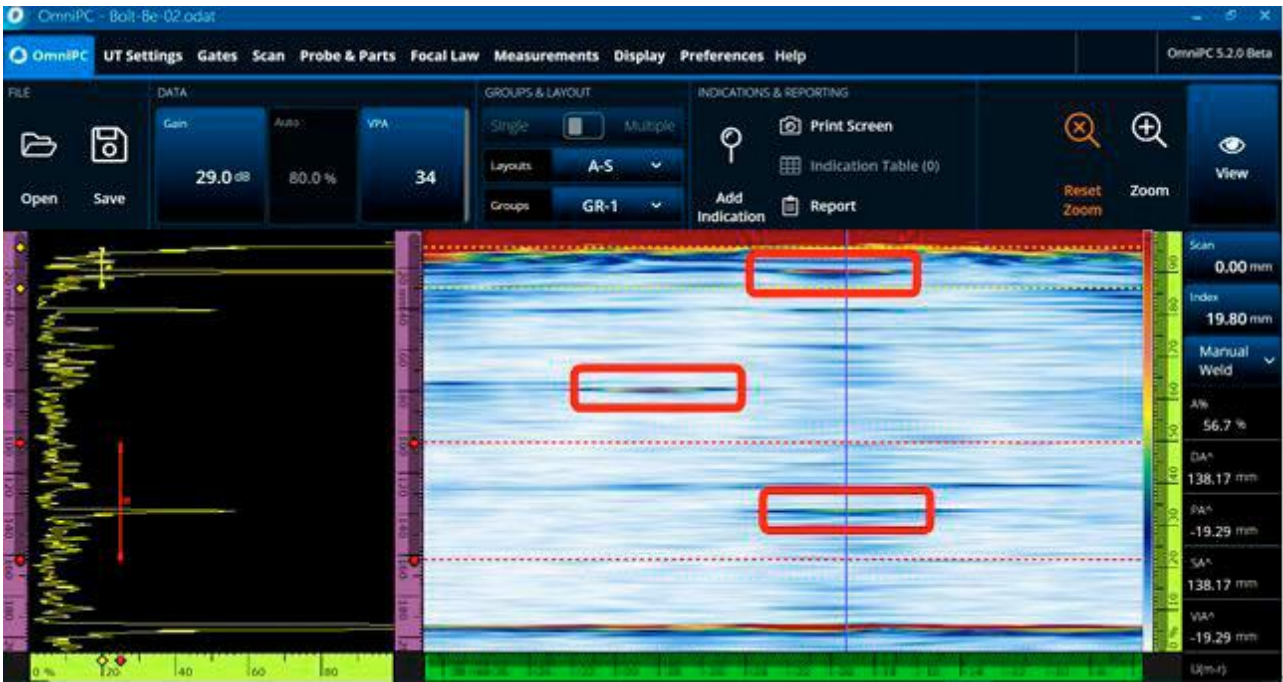
Figure 6. For the defect (groove) located 140 mm from the top surface, its detected depth was 138.17 mm.

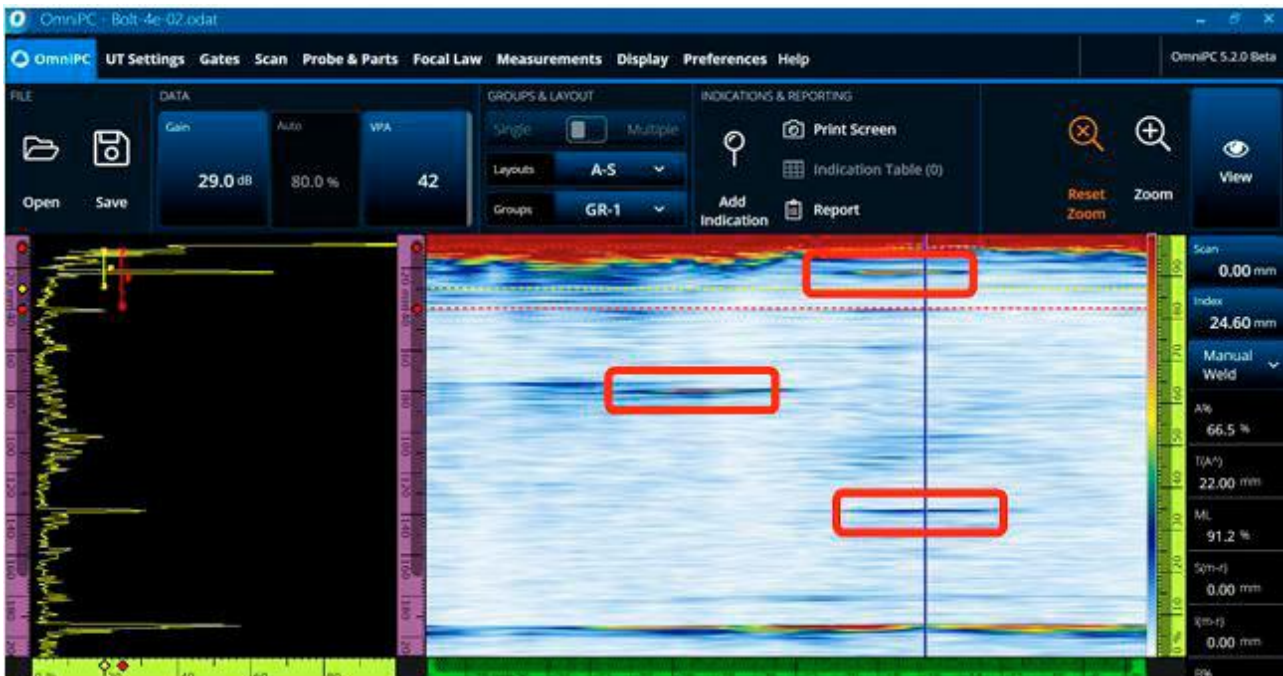
Figure 7. The signals for the shallower defects (grooves) located at 20 mm and 80 mm from the top surface are strong and the indications are clear, whereas the signal for the defect (groove) at 140 mm was weaker.

Next, we excited only 4 elements at one time, and all the other conditions remained unchanged. The test results we obtained are shown in Figure 7.

Firing sequence: 1-4, 2-5, 3-6,...61-64

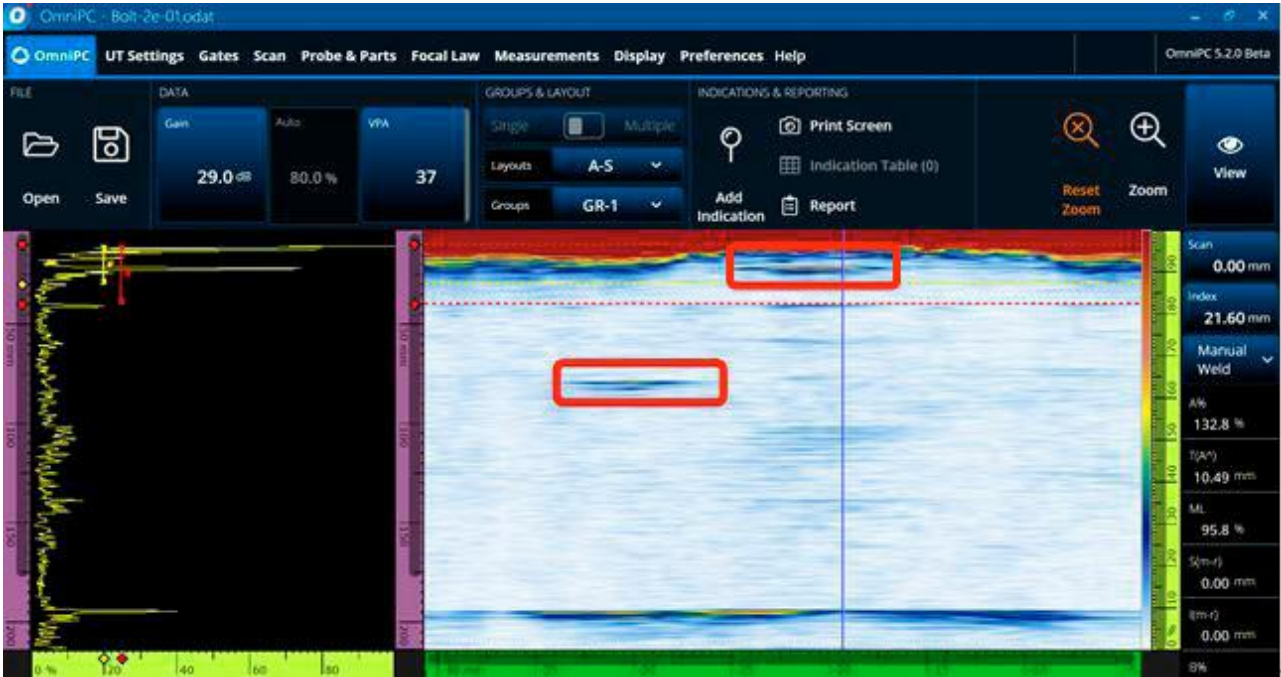
Figure 8: The signal for the defect at 140 mm from the top surface was almost undetectable using two elements.

When only 2 elements were simultaneously fired, the signal for the defect at 140 mm from the bolt head's top surface was almost undetectable (see Figure 8).

Firing sequence: 1-2, 2-3, 23-4,...63-64

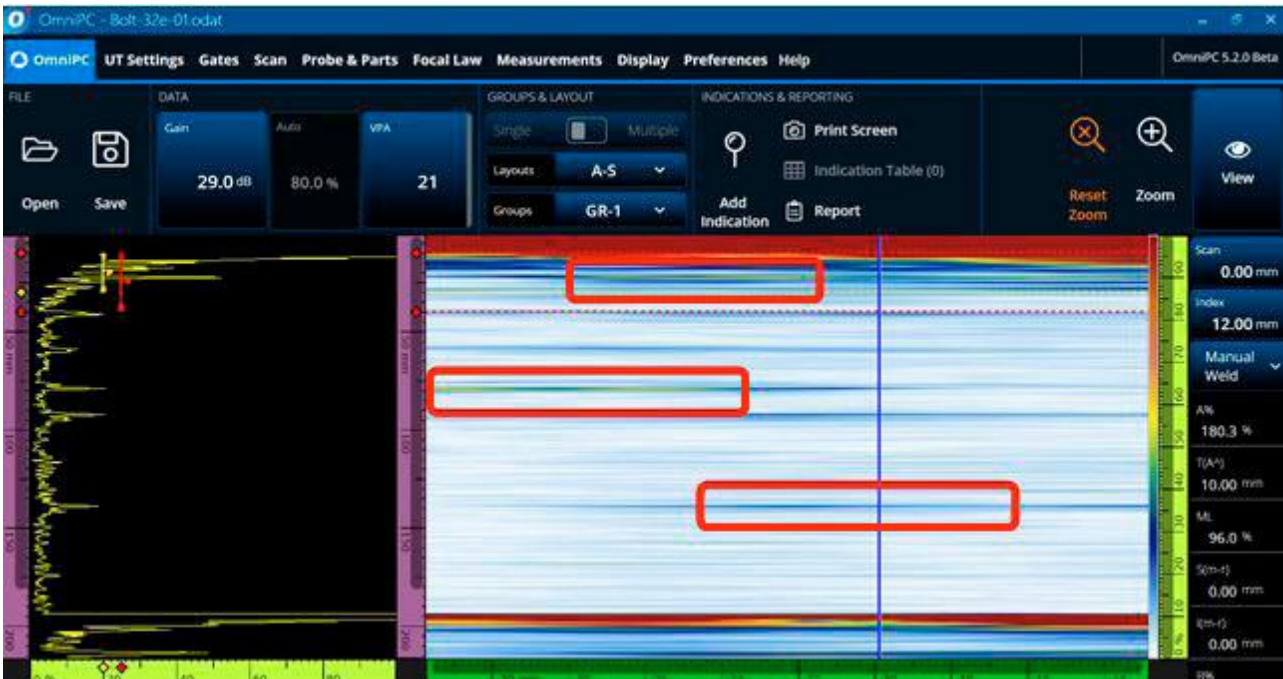
Figure 10: Test results obtained with 32 elements simultaneously excited.

Then we tried firing 32 elements simultaneously, i.e., half of all the elements forming a half circle. Because these 32 elements were arranged in a semicircular arc and were not in a straight line along a horizontal plane, the acoustic beam could not focus, thus resulting in severely distorted signals and making it almost impossible to find the signal for the defect located at 140 mm from the bolt head's top surface (see Figure 10).

Firing sequence: 1-32, 2-33, 3-34,...33-64

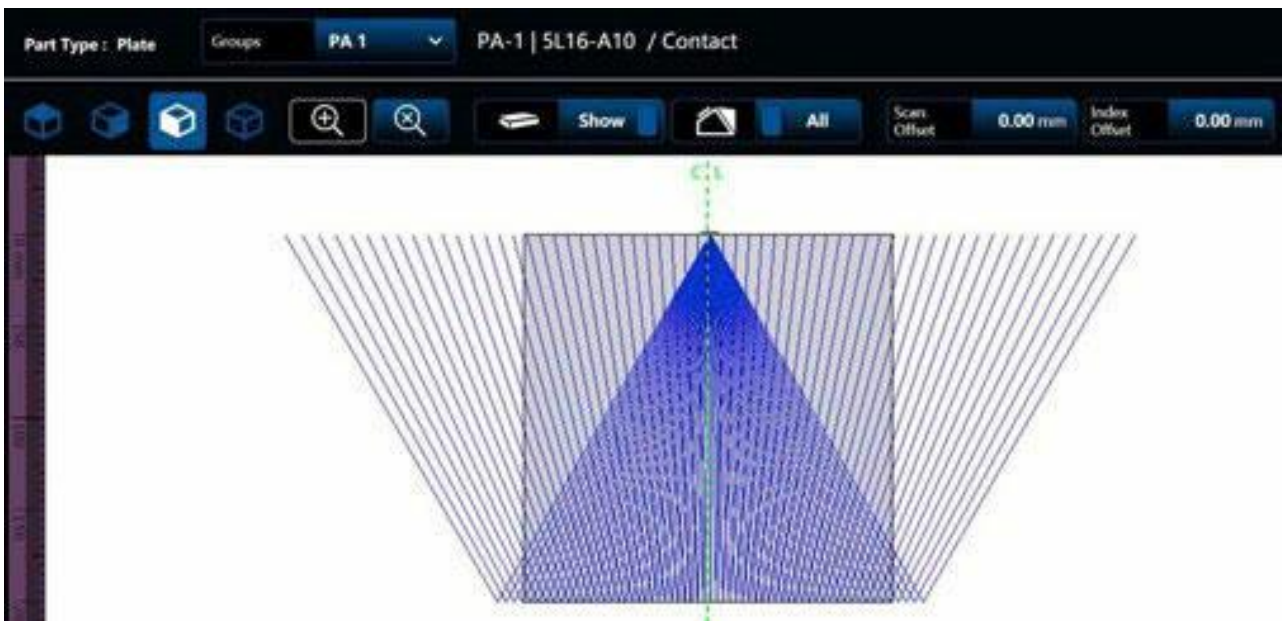
Figure 11. Beam schematic for the linear array probe on the OmniScan X3 flaw detector

This test was conducted to provide a comparison of the ring array probe's performance with that of a typical linear phased array probe (Figure 11).

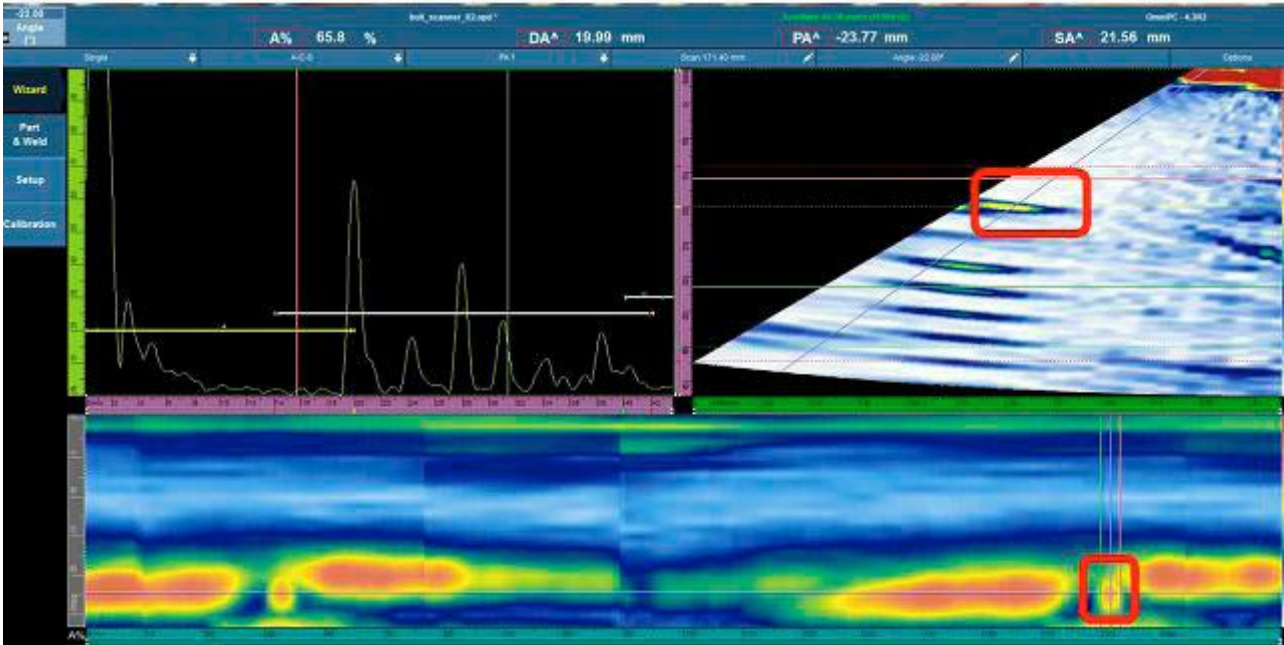
Figure 12. Scan results for the defect located at 20 mm from the bolt head's top surface.

We managed to detect all the defects in the bolt using a linear array probe and a sectorial scanning technique; however, it required additional steps. To detect the defect located at 20 mm from the bolt head's top surface, it was necessary to use a wedge to increase the beams' angle of incidence. In addition, the signal for this defect and the signal for the edge of the bolt head's bottom surface were too close together to distinguish them (Figure 12).
